Campaign No. 2015050001, May 2015

SUBJECT: **Model 906 (Sprinter) with Engine 651 (4-Cylinder Diesel)**
Model Year 2015
Replace Timing Chain Tensioner Sealing Ring

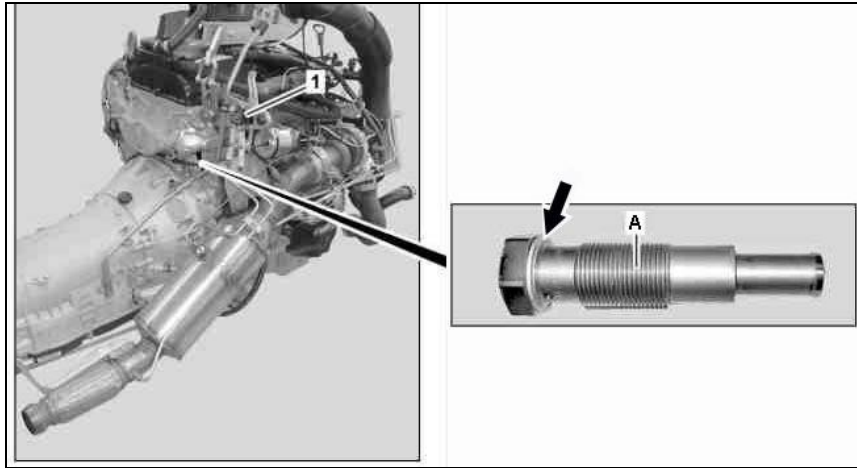
Figure 1 (A: Timing Chain Tensioner 1: Mounting bracket Arrow: Timing chain sealing ring)

Daimler AG (DAG) has determined that on approximately 1,338 Model Year 2014-2015 Mercedes-Benz and Freightliner Sprinter vehicles, the chain tensioner sealing ring on the 4-cylinder diesel engine may have experienced variations in material tolerances during a certain production period. Such sealing rings may exhibit an increased settling behavior, which could negatively influence the pretensioning force. Over time, this might lead to loosening of the chain tensioner, as well as an ineffective sealing ring seal for engine oil. As a consequence, leakage of engine oil onto the road might pose a threat to traffic. Should the oil leakage reach a certain amount the engine might stall. Oil leakage in the presence of an ignition source could also increase the risk of a potential fire. An authorized Sprinter dealer will replace the chain tensioner sealing ring.
